# **VERIFICATIONS ON SEISMIC STRENGTHENING OF THE EXISTING RC BUILDING**

Kazushi SHIMAZAKI <sup>1</sup>

It was decided to demolish the three-story seismically strengthened “Building 4” at Kanagawa University, which was a five-story building when it was originally built in 1963. Presented with this opportunity, we planned two series of full-scale tests to evaluate the actual strength of this seismically strengthened building. One was an in-situ test of the frame, which had been seismically strengthened with a new steel brace, and the other involved member tests on two columns and a beam-column joint. During the in-situ test, the maximum horizontal force applied was 1.1 times the calculated horizontal strength based on the actual strength of the materials. In the member tests, one column experienced shear failure; the others suffered bending failure along the connecting beams. The beam-column joint specimen experienced shear failure on the beam. The obtained strengths can be estimated on the safe side by the common evaluation formulas.

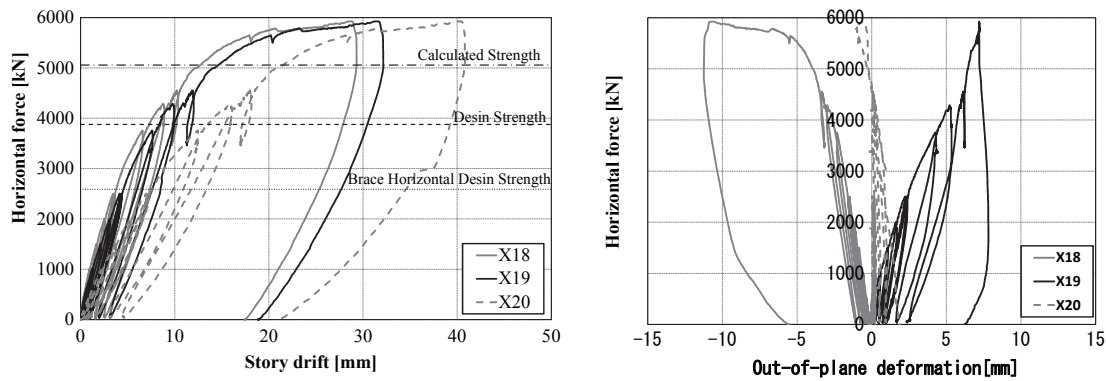
Figure 4. Test results

Figure 4(a) shows the relationship of the second story drift and the horizontal force, and Fig. 7(b) presents the out-of-plane deformation. Photo 2 shows the final destruction situation. The progression of damage was as follows. Bending cracks occurred in the column capital and base of the X20 column at 1,000 kN. At 2,500 kN, bending cracks occurred in the X18 column and the X19 ~ X18 beam. There was no loss of stiffness until the loading cycle reached 3,750 kN of horizontal force, and the story drift

Out-of-plane deformation on the X18 line is in the direction of the building exterior, and the opposite side on the X19 line. It is about 80% of the horizontal deformation at 2,500 kN, about 50% at 3,750 kN, and about 30% at maximum strength. It is considered that this torsional deformation is impeded because it is constrained by the orthogonal beam and slabs in the actual building; however, careful consideration of the confined stress is necessary.

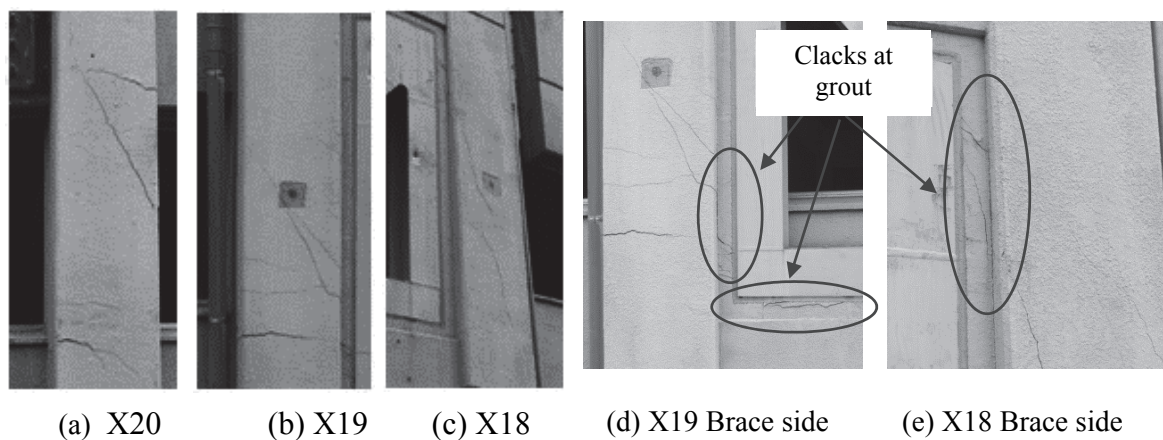
Photo 2. View of the final damage

was less than 1/400 at that cycle. Stiffness did decline above 4,500 kN of horizontal force, with much greater deformation. Ultimately, the brace yielded and the RC columns suffered shear failure as shown in photos 2(a)-(c). The grout-filled section of the junction with the brace was damaged, but did not result in destruction of the anchor or stud as shown in photos 2(d)-(e).

The maximum horizontal force applied was 5,920 kN. The strength calculated using the strengthening design manual (JBDPA, 2001) was 3,799 kN, and the strength based on the actual strength of the material and the solid cross-section of the member was 5,056 kN. This value is the sum of 3,377 kN for the horizontal component of the yield strength of the braces and the horizontal strength of the RC columns with the vertical steel frame shown in Fig. 5. Flexural strength  $M_u$  of the RC columns was calculated using the ACI stress block method (ACI 2011). Shear strength  $Q_u$  was calculated using Equation (1) (Arakawa 1960). The experimental value proved to be 1.9 times the design strength and 1.2 times the computed value.

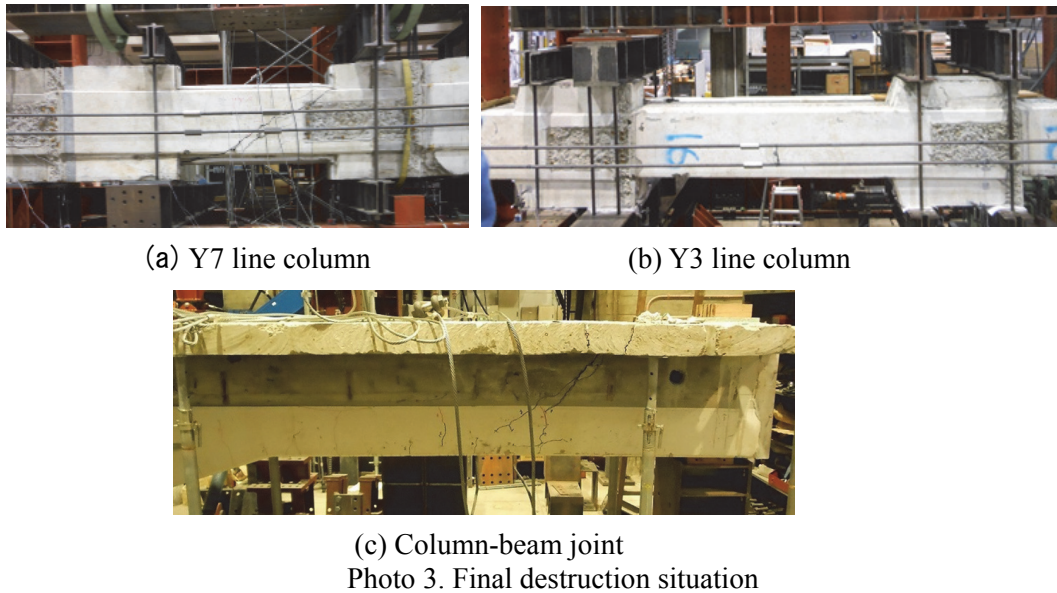
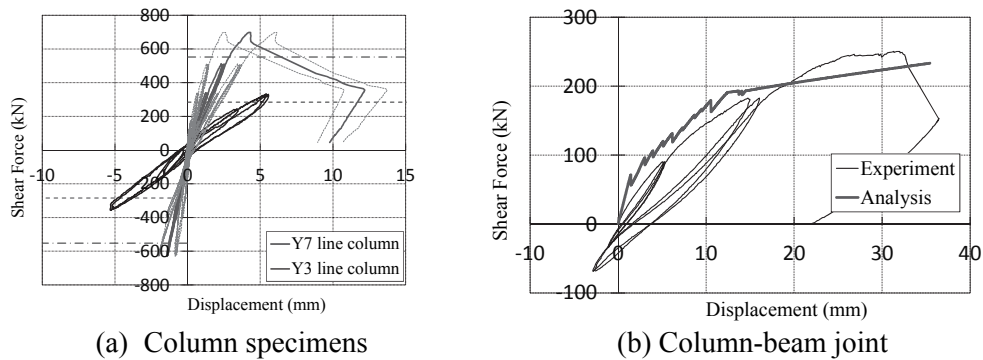
Figure 10. Test results

Photo 3 shows the situation upon final destruction. Figure 10 shows the relationship between the shear force and deformation. For the Y7 line column, a bending crack was observed at 143 kN, and a shear crack (crack width: 0.05 mm) was induced at 366 kN, but without any reduction in stiffness. Finally, a shear fracture occurred at 698 kN. The shear crack entered to form a diagonal line along the column on the side of the eccentric beam, and it extended to the beam-to-column joint on the other side. The calculated shear strength according to Equation (1) using the actual strength of the material is 552 kN, which is shown in Fig. 10(a) as a one-dot dashed line. The experimental value was 1.26 times the calculated value. In the relationship between the shear force and deformation shown in Fig. 10(a), this column has three lines because the test specimen was not fixed to the frame completely, and the load control was not accurate. The anti-symmetric moment seemed to fluctuate, so the value of  $M/Qd$  was not constant during the test.

The other column of the Y3 line experienced bending failure of the connecting beam. At the cycle at one third of the design strength, flexural cracks are observed. At 244 kN, there were signs of concrete crushing in the compression position of the beam. Then, the load control was changed to deformation control. At  $R=1/100$  (339 kN), the compression zone of the beam was crushed. The loading jig was inclined by the collapse of the beam because the beams are eccentric to the column as shown in Fig. 7(b), so loading was discontinued. The maximum load applied was 357 kN. This specimen was the weak-beam strong-column type. The calculated shear force value at the ultimate bending strength of the connecting beams is 174 kN. The dashed line in Fig. 10(a) is the shear force value with the crushing strength in the compression region of the connecting beams. The actual shear strength of the column is larger than these values.

For the beam-column joint specimen, at 250-kN shear force ( $R = 1/100$ ), the beam suffered shear failure on the loading side of the beam. The weld of the fixing plate for the main reinforcement at the cut surface gave way. The main reinforcement of the beam is largely at the column end, and it is cut off in the center part as shown in Fig. 7(c). The shear forces at the ultimate bending strength of the cut-off position and at the column end were 253 kN and 310 kN respectively. The value at the cut-off position is smaller than the value at the column end. Shear reinforcement of the central portion is small and the shear capacity based on Equation (1) is 236 kN, but is 497 kN at the column end portion. As shown in Fig. 10(b), stiffness declines with about 25-mm displacement (250 kN of shear force). This seems to be the ultimate bending strength at the cut-off position. The analysis results using a simple fiber model with variable cross-sectional beams show the main reinforcement yields at the cut-off position. The calculated results shown in Fig. 10(b) as a dark solid line afford good correspondence with the experimental results. For the actual building, the vertical loads are distributed, and the shear force is small in the central portion. This member test was planned to simulate the moment gradient during an earthquake considering a vertical load effect. As the load was applied with a concentrated load, the shear force was constant over the entire length. As a building member, the beam would not experience shear failure.
