# **VERIFICATIONS ON SEISMIC STRENGTHENING OF THE EXISTING RC BUILDING**

Kazushi SHIMAZAKI <sup>1</sup>

It was decided to demolish the three-story seismically strengthened “Building 4” at Kanagawa University, which was a five-story building when it was originally built in 1963. Presented with this opportunity, we planned two series of full-scale tests to evaluate the actual strength of this seismically strengthened building. One was an in-situ test of the frame, which had been seismically strengthened with a new steel brace, and the other involved member tests on two columns and a beam-column joint. During the in-situ test, the maximum horizontal force applied was 1.1 times the calculated horizontal strength based on the actual strength of the materials. In the member tests, one column experienced shear failure; the others suffered bending failure along the connecting beams. The beam-column joint specimen experienced shear failure on the beam. The obtained strengths can be estimated on the safe side by the common evaluation formulas.

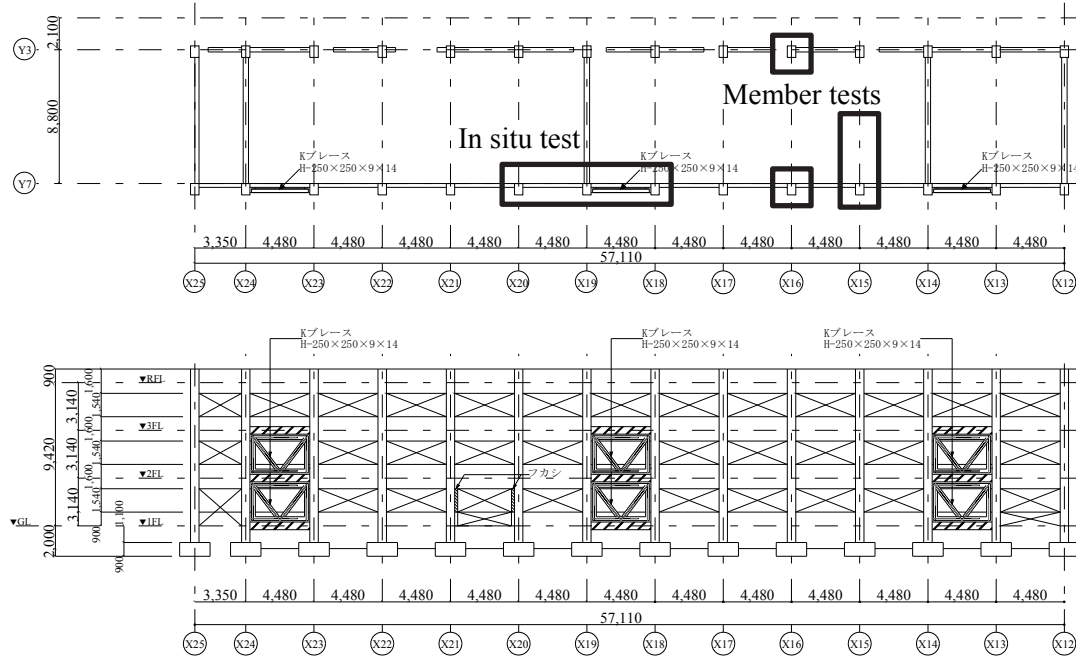
Figure 1. Outline of seismic strengthening (X Direction)

The remaining three-story building was seismically strengthened with K-type steel-framed braces, reinforced concrete shear walls, with slits placed to improve the brittle column, as shown in Fig. 1. The seismic capacity evaluation (JBDPA, 2001) after strengthening indicated that the structure retained sufficient earthquake resistance.

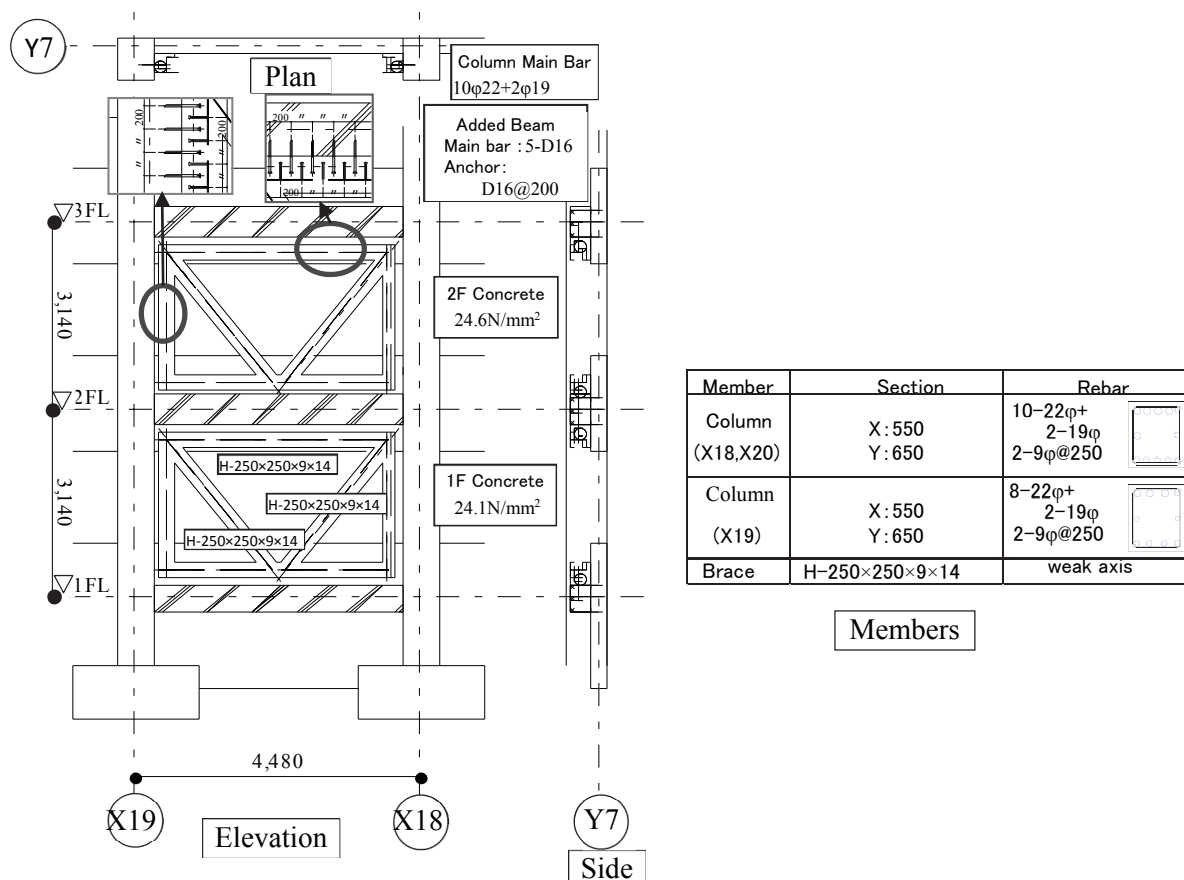
Figure 2. Outline of seismic strengthening with K-type steel braces

Figure 2 presents a brace mounting diagram. A K-type steel-framed brace was installed within the frame just outside the wall girder, with an additional beam attached to the outer face. The upright frame member of the brace frame extended to the rigid section of the existing RC columns and wall girders. A cross-section of the main member is represented in Fig. 2. The main reinforcement bars for the columns and girders were SR24 (SR235) round bars of 22 or 19φ, the shear reinforcements were SR24 (SR235) round bars of 9φ, and the second story concrete strength averaged 24.6 N/mm<sup>2</sup>. The brace and frame members used had dimensions of H-250 × 250 × 9 × 14 (SS400).

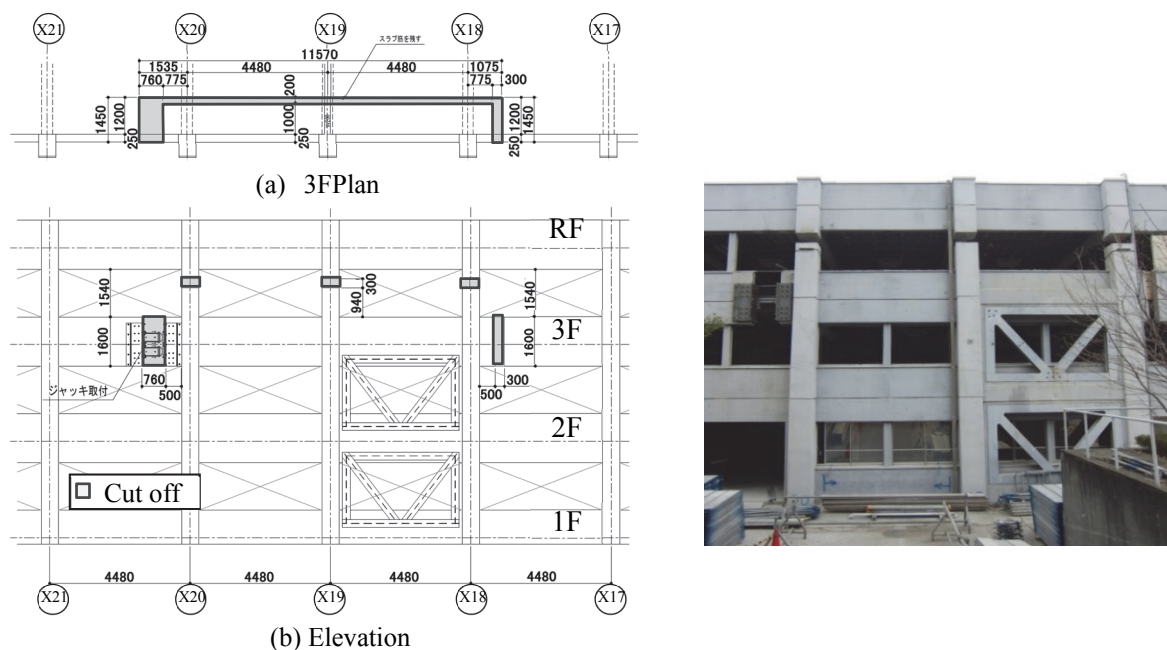
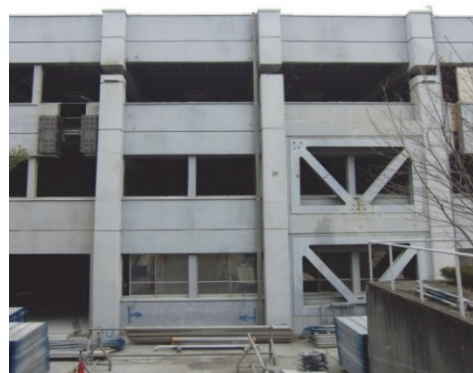
Figure 3. Test portion

The test portion as shown in Fig. 3 is the second story with columns cut between the ceiling and the third floor, and wall girders cut on the third floor between the X17-19 and X20-21 lines. The horizontal strength of the brace expected from the strengthening design manual (JBDPA, 2001) was 2,420 kN. A horizontal force was applied as one-way repetitive loading using two hydraulic jacks. The displacements of the vertical and horizontal direction from the centroid line of each floor were also measured. Since torsional deformation of the frame is assumed, out-of-plane displacements of the beam on the third floor were also measured. The strain of the braces and frame members was also measured using strain gauges. The horizontal force was applied with a load control. The loading cycle is one-way loading of 500 kN once, 1,000 kN twice, 1,500 kN and 2,000 kN once each, 2,500 kN three times, 3,750 kN and 4,000 kN once each, until finally reaching maximum strength.

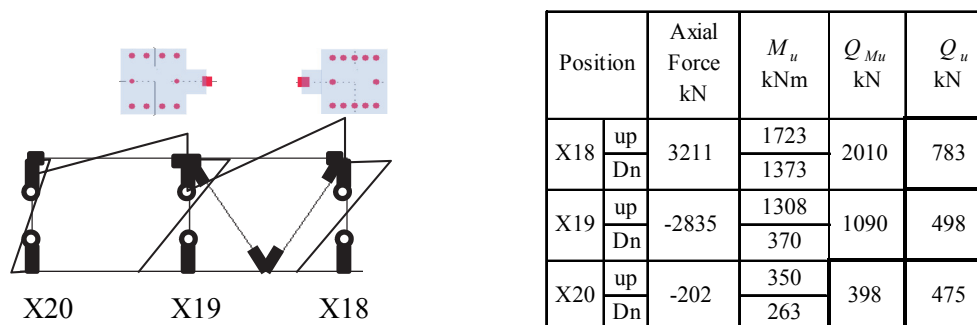
Figure 5. Analytical model and computed results

In order to evaluate the stiffness and strength, an analysis using a three-dimensional frame elastic-plastic analysis program was carried out. The analytical model was a one-story plane frame model as shown in Fig. 5. The multi-spring model shown in Fig. 6(a) was used as the member model for the columns. The steel vertical frame member of the brace frame was considered to be part of the section of the X18 and 19 columns. The X19 column also has an orthogonal wall. The structural centroid position of the section was considered as the center of gravity for the steel, reinforcing bars and concrete in consideration of the ratio of Young's modulus for the X18 column. For the X19 column, which is a tensile column, it is the center of gravity of the steel and reinforcing bars ignoring the concrete. These structural centroid positions are shown in Fig. 5 as "CL". The top ends of X18 and 20 columns had the anchorage rebars of the orthogonal beams (3-25 $\phi$ ). Elastic stiffness was assumed to be an equivalent cross section. In order to assess the expected shear strength of the steel vertical frame, the X18 and 19 columns were assumed to have the shear strength with 1% of the elastic stiffness after any shear failure of the RC column. The thick solid line in Fig. 6(b) shows the analysis results. The results demonstrate good correspondence with the experimental results, except for the stiffness degradation at 4,000 kN.
