Experimental Study on Reinforced Concrete Dampers Using De-Bonded Deformed Bars

Kazushi Shimazaki Kanagawa University, JAPAN

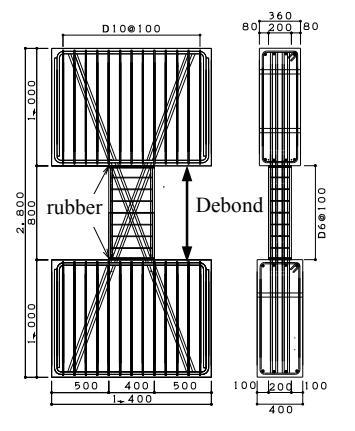
Figure 2. Details of RC stud column damper

The geometries and details of the stud type damper test specimens are shown in Figure 2. Two specimens are tested. The full-scale stud columns have a cross section of 200×400 mm and length of 800 mm with stubs at both ends. In order to absorb the geometric shaft elongation, 10 mm-thick rubber plates are placed at the end division of the stud part throughout the cross section. The deformed bar is de-bond processed by filling the internodes with wax and covering by butyl rubber. The mechanical properties of the material are shown in Table 1.

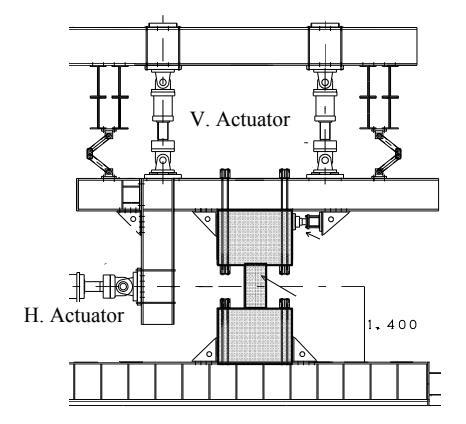
Figure 3. Test set-up of RC stud column

Antisymmetric moment was applied to the specimens using a horizontal actuator as shown in Figure 3. Two vertical actuators are controlled to keep the upper stub horizontal and no axial elongation for the test specimen No.1, and no axial load for the test specimen No.2. Test specimen No. 1 will have variable axial force and specimen No. 2 will have axial elongation. These are assumed to be the extreme case of the boundary condition on the top and bottom floor by beams. In an actual structure, the behavior was regarded as intermediate between these cases. The loading cycle is one cycle at R = 1/700, three at R = 1/400 and 1/200, six at R = 1/100, three at R = 1/67 and R = 1/40, and finally

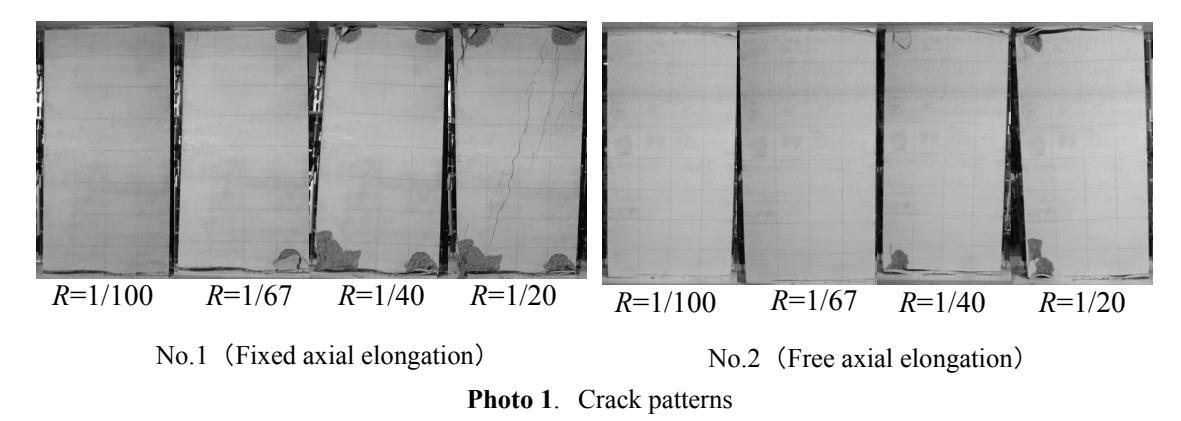
Crack patterns of each test specimen are shown in Photo 1.

At R = 1/200, both test specimens showed no cracks, having only an opening at the clearance between the rubber and concrete. For No. 1, minute cracks appeared in the edge at R = 1/100. At R = 1/67, thin surface concrete exfoliated in the edge of the upper part. Shear cracks did not form until R = 1/40. Finally, diagonal shear cracks occurred at R = 1/20. For No. 2, no shear cracks were observed until the final cycle, and only thin surface concrete exfoliated at R = 1/40.

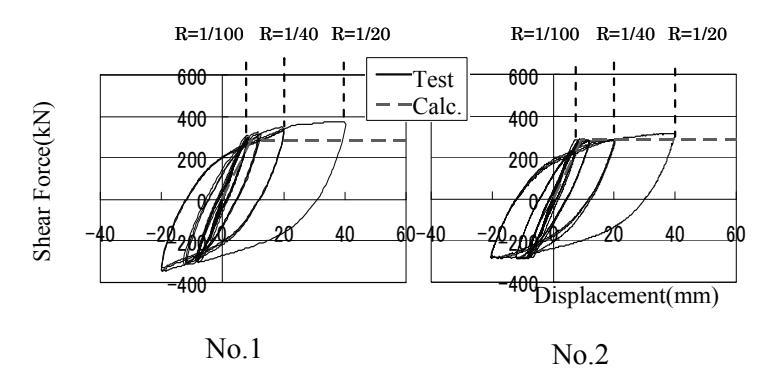
Figure 4. Relationships of shear force and displacement

The relationships of shear force and displacement of the specimens are shown in Figure 4. In this figure, the calculated values are also shown, assuming that the X rebars as a truss have a bilinear stress–strain relationship.

The experimental values for No. 1 were higher than the calculated ones, in contrast with the values for No. 2 which almost matched. The maximum difference in both test specimens was about 60 kN, which seems to be related to the method of controlling elongation. In addition, the rubber depth at the edge was not sufficient to absorb the elongation during large deformation, so a compressive force was transmitted to the concrete and surface concrete exfoliated at the edge. Both test specimens suffered little damage, and the load resistance did not degrade.

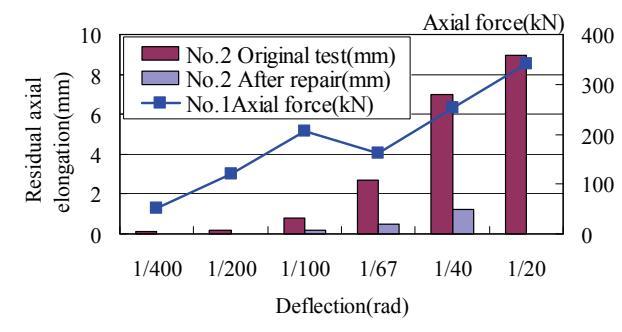
Figure 5. Axial load & axial elongation-deflection curves

Figure 5 plots the residual axial elongation of specimen No. 2 on the left vertical axis, and the axial force of specimen No. 1 on the right axis at the final cycle for each deformation level shown on the horizontal axis. In this figure, the data tested after repair are compared for specimen No. 2.

For specimen No. 2 shown in the bar chart, axial elongation appears after R = 1/100 when X bars yielded. At R = 1/40, the elongation became large because the gaps at both ends were closed. The final residual elongation was 9 mm after large deformation of R = 1/20. The data after repair show very small values. The maximum amount of increase was 1.3 mm at R = 1/40 calculated from the last data before repair as the initial value; this was because the gaps at both ends expanded during the first test. For specimen No. 1 shown in the line chart, axial force increased until R = 1/100 when X bars yielded, and after R = 1/40, it increased again because the gaps were closed. In the design, if beams are assumed to be rigid, this axial force is applied to the beam, whereas if beams are assumed to be non-rigid, the beam is forced to deform caused by the axial elongation.

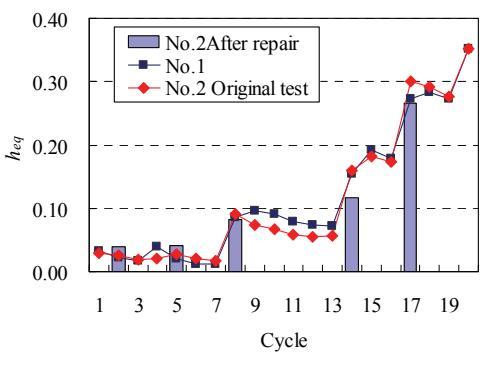
Figure 6. Equivalent damping factor

Figure 6 shows the equivalent damping factor for each specimen calculated from the first half cycle of the applied load-total deflection relationship shown in Figure 3.

Above R = 1/100, the equivalent damping factor reaches 0.1 for both specimens. For the repeating cycle of R = 1/100, the values of specimen No. 1 are large compared to those of No. 2. At the other points, the values are almost the same, including those of No. 2 after repair. This means that the RC stud column damper performs well as a damper even after repair from large deformation.

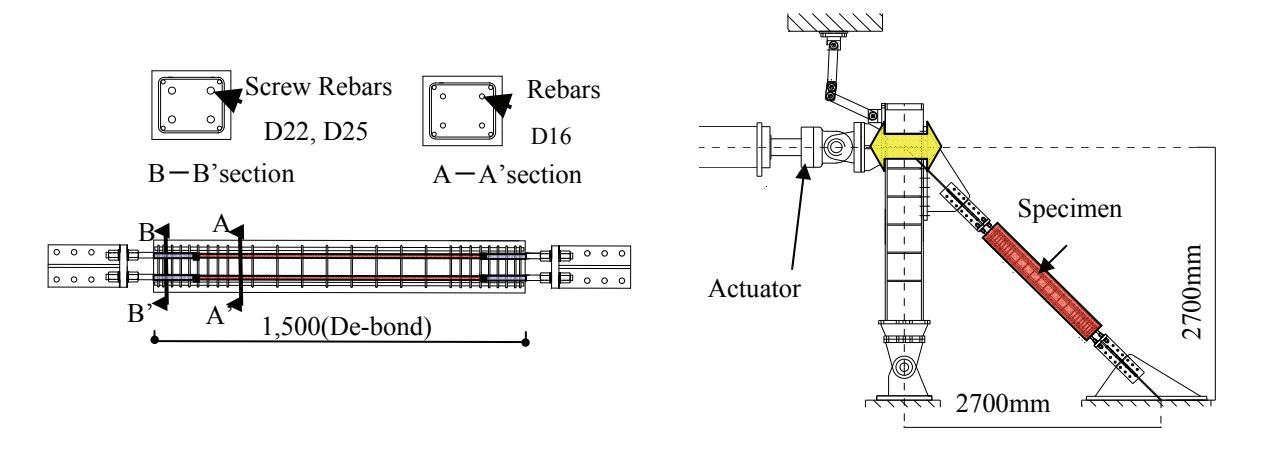
Figure 7. Detail and bar arrangements of test specimens

Figure 7 shows the detail and bar arrangements of test specimens. The cross section of the specimens

is 240×210 mm and the length is 1500 mm. At both ends, the deformed bars are thick, and both rebars are connected by friction welding. At the weld point, the midsection thin rebars are covered by butyl rubber as large as the diameter of the end part rebars to act as a buffer to yield in compression. Both the end part and midsection rebars are de-bonded. The end part rebars are filled to a sufficient length in RC to avoid compression buckling. Both ends are fixed by additional steel plates to attach the loading frame. The test set-up is shown in Figure 8.

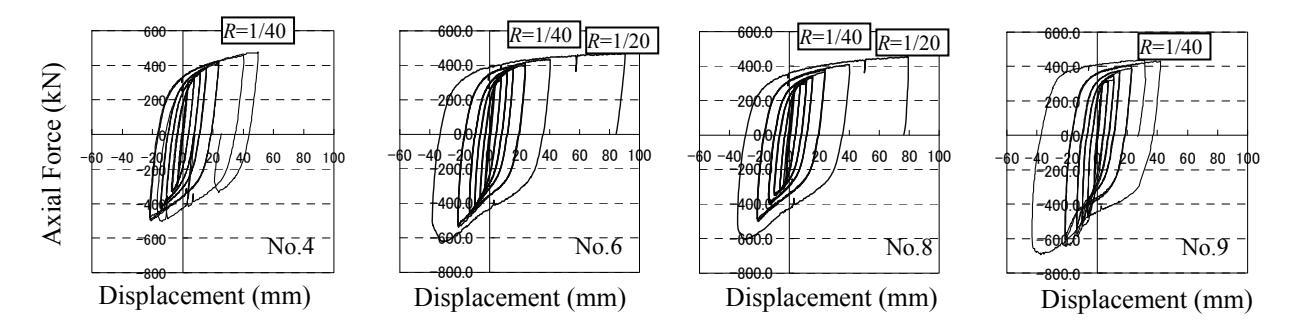
Figure 9. Axial load-axial deflection relationships

Axial load-deflection relationships are shown in Figure 9 for typical specimens. Only the bonded specimen No. 1 suffered subsidiary fracture at a weld point during the R = 1/67 loading cycle. For specimens No. 2 to 4 whose end rebars were small, the end bars buckled at R = 1/100 - 1/40. Then,

the loading sequence was modified only on the tension side after buckling. Specimens No. 5 to 7 showed good performance until R = 1/20. Specimen No. 8 suffered degraded load capacity at R = 1/40 in compression loading with increasing cracking of confining concrete, though the performance was not so poor. Specimen No. 9 containing bonded round bars showed good performance until R = 1/40, but subsidiary fracture at the weld point thereafter. The specimens with less "clearance" showed large compression resistance caused by the transfer of stress to confining RC by friction, without absorbing the cubical expansion in the compression side. This appeared to serve to increase the crack.

Figure 10 shows the cumulative absorption energy of each specimen calculated from the area of the axial load-axial deflection relationship shown in Figure 9. Significant differences are not observed except for specimens No. 1 to 4, which buckled at the end part rebars because they had insufficient section.

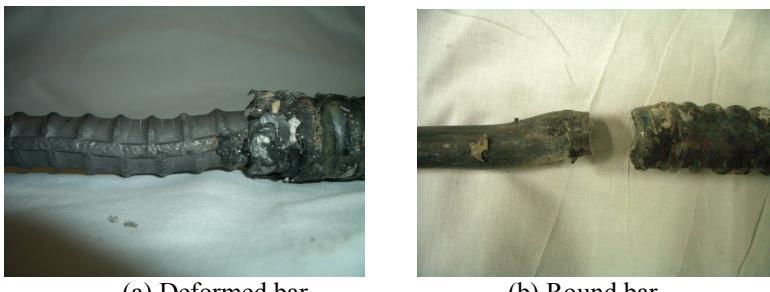
Photo 2. Final state of bars at weld point

Photo 2 shows the final state of rebars after removing the confining RC cover. The deformed bar buckled gently in the weak axis in contrast to the round bar which buckled sharply only in the buffer zone and suffered subsidiary fracture. This indicates the advantage of using deformed bars.

(a) Deformed bar

(b) Round bar

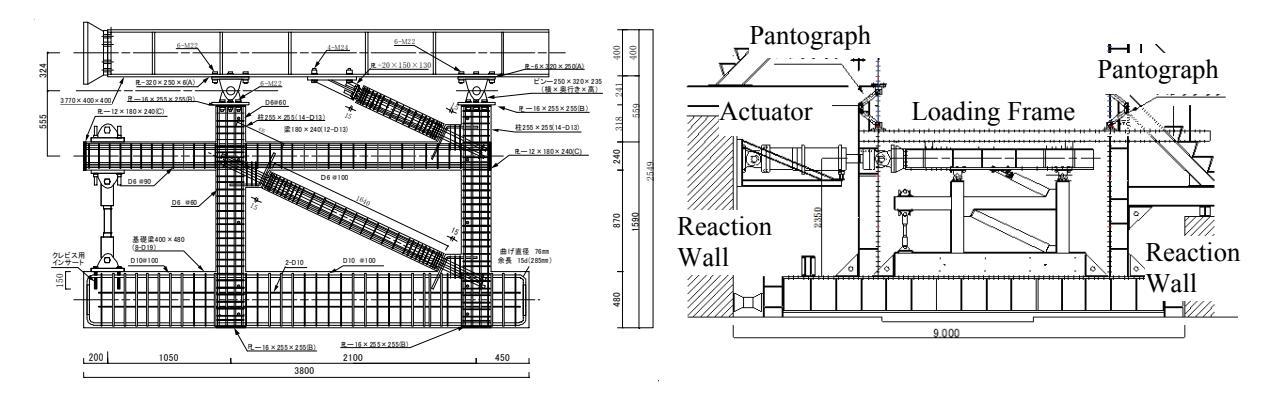
Figure 11. Detail and bar arrangements of test specimens

One test specimen was prepared at one-third scale, and was designed to confirm the condition of column-beam-brace connections. Figure 11 shows the detail and bar arrangements of the test specimens. The cross section of the columns is 255×255 mm with 14-D13 rebars and 870 mm clear span. The beam is 180×240 mm section with 12-D13 rebars and 1845 mm clear span. The brace is 180×160 mm section with 4-D13 rebars at the center part and 4-D19 rebars at both ends. The total length is 1640 mm and the length of the center D13 part is 1250 mm. This length is determined to yield at R = 1/250. At both ends, there are 15-mm clearances so that the rebars yield in compression. The end part rebars are filled to sufficient length in the beam-column joint with fixing plates. The test set-up is shown in Figure 12. Cyclic horizontal force is applied at the top loading steel frame. The loading cycle is one cycle at R = 1/700, three at R = 1/400 and 1/200, six at R = 1/100, three at R = 1/67 and R = 1/40, and finally one-way loading to R = 1/33.

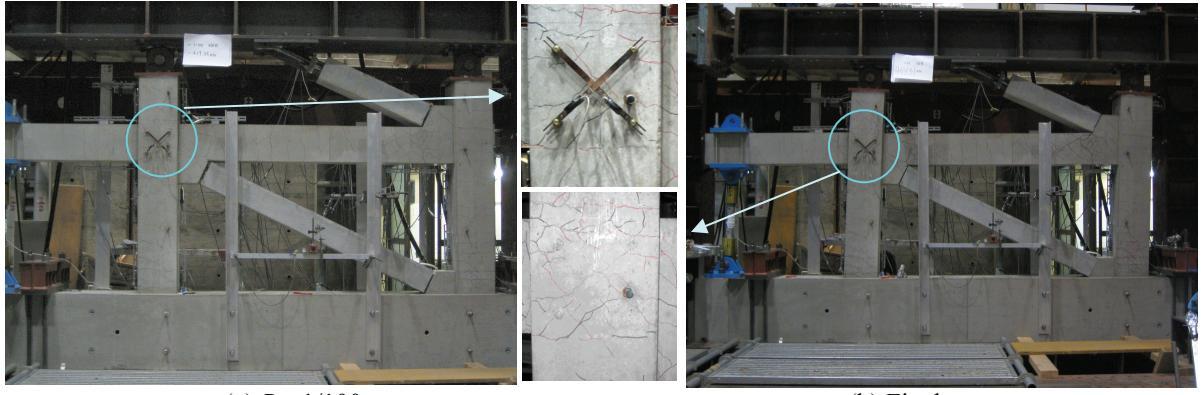
Photo 3 Crack Patterns

During the response in the R = 1/200 cycle, bending cracks were observed at beam ends and column ends. The center rebars in the brace yielded at the R = 1/200 cycle. Bending-shear cracks were observed for the beam at the R = 1/100 cycle. Damage to the brace was very small until final loading. Crack patterns at R = 1/100 and at the final cycle are shown in Photo 3. Cracks are not severe in the beam-column connection zone.

(a) R = 1/100

(b) Final

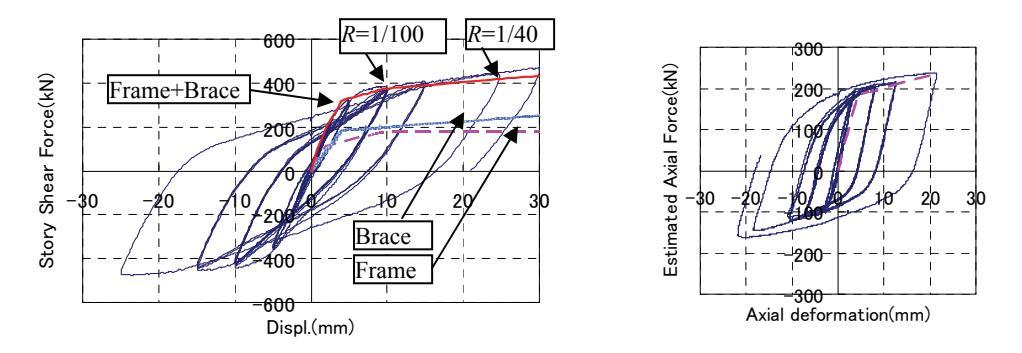
Figure 13. Horizontal load-horizontal deflection

The horizontal load-horizontal deflection behavior is shown in Figure 13. Very ductile behavior was observed until R = 1/40 with very fat hysteresis loops. In this figure, calculated values are also drawn.

"Frame" means the value calculated by nonlinear space frame analysis, while "brace" means the value calculated from the axial yield strength and deformation of rebars. The relationship between brace axial force estimated from the strain of the end reinforcing bar and axial displacement is shown in Figure 14. In the compression side, the strain decreases because concrete works with bars. However, it seems possible to estimate the axial force in the tension side. In this figure, the bi-linear relationship

with the assumption of 7% second modulus to the elastic stiffness is superimposed. The correspondence is good. The relationship shown in Figure 13 is modified to the relationship in the horizontal force–horizontal displacement. "Frame+Brace" means the sum of "Frame" and "Brace". The calculated values show good agreement with the test results.

Figure 14. Estimated axial force-axial deformation

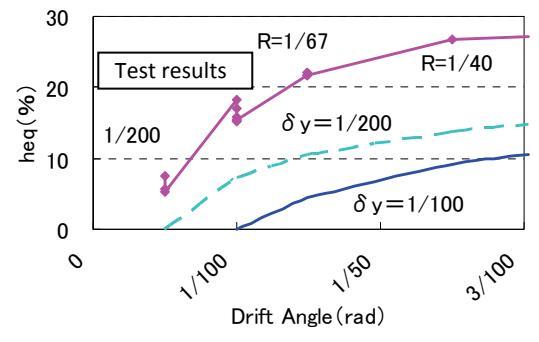
Figure 15. Equivalent damping $factor(h_{eq})$

Equivalent damping factors at each loading cycle are shown in Figure 15. In this figure, common values for RC frame structures defined by the Japanese building code are compared, showing that values almost two to three times as large are obtained. This means that the system used here is on the high ground to absorb earthquake energy.
